DEPARTMENT OF TRANSPORTATION**DIVISION OF ENGINEERING SERVICES**

Contract #: 04-0120F4Cty: SF/ALA Rte: 80 PM: 13.2/13.9File #: 1.28**WELDING INSPECTION REPORT****Resident Engineer:**Pursell, Gary**Address:** 333 Burma Road**City:** Oakland, CA 94607**Report No:** WIR-013216**Date Inspected:** 22-Apr-2010**Project Name:** SAS Superstructure**OSM Arrival Time:** 630**Prime Contractor:** American Bridge/Fluor Enterprises, a JV**OSM Departure Time:** 1500**Contractor:** American Bridge/Fluor Enterprises, a JV**Location:** Job Site

Bridge No: 34-0006**Component:** SAS OBG 2W/3W-A, 3W/4W-A,1W/2W-E**Summary of Items Observed:**

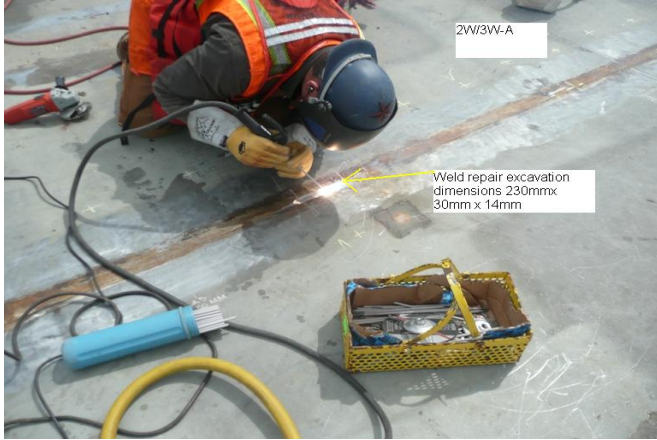
The QA Inspector randomly observed the SE QC Inspector Jesse Cayabayab perform dimensional verification of the above identified weld joint prior to welding. The QA Inspector noted the dimensional inspection included indicating the areas of the weld joint with planar misalignment and the gaps at the steel backing and the bevel that exceeded 2mm. After the QC Inspector had completed the dimensional inspection, the QA Inspector observed the ABF welding personnel including Dan Ieraci begin performing additional fit up tasks to correct the areas of the weld joint the did not meet the tolerances of AWS D1.5 section 3.3.3 and 3.13.5. The QA Inspector randomly observed an ABF representative under the top deck plate utilizing a porta power hydraulic jack to push the steel backing flush with the top deck plate in the areas previously indicated by the QC Inspector to have excessive gaps. After an area was corrected with the porta power jack, the ABF welder Jordan Hazelaar performed SMAW tack weld to secure the steel backing to the bevel. The QA Inspector noted the above identified process was repeated at each location where the steel backing gap exceeded 2mm. In addition the ABF welder Salvador Sandoval began installing fitting aids at the locations indicated by the QC Inspector where the planar misalignment exceed that allowed by AWS D1.5-02 section 3.3.3. The QA Inspector noted the fit up tasks were performed for the duration of the QA Inspectors shift.
